## **FIRE PERFORMANCE EVALUATION OF GLASBORD FPAUS IN ACCORDANCE WITH AUSTRALIAN STANDARD™ (AS) ISO 9705-2003, FIRE TESTS-FULL-SCALE ROOM TEST FOR SURFACE PRODUCTS**

**FINAL REPORT**  
Consisting of 20 Pages

**SwRI Project No. 01.24102.19.310**  
**Test Date: February 26, 2019**  
**Report Date: March 12, 2019**

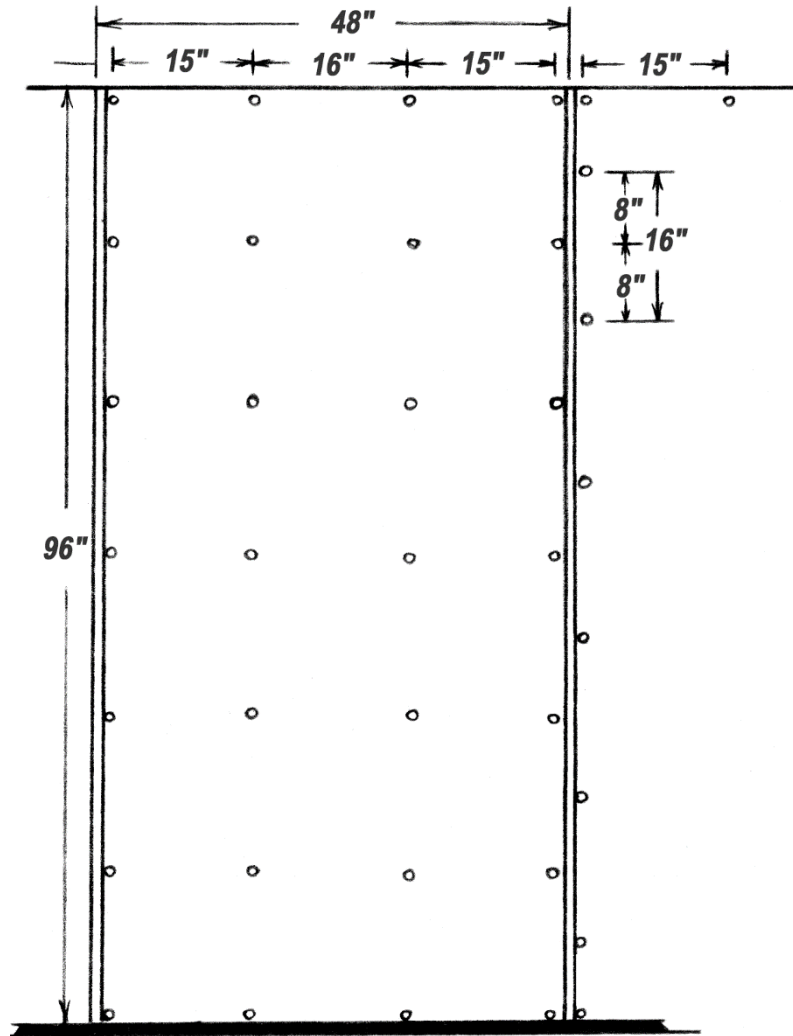
**Figure 1. Client-Provided Attachment Layout.**

The panels were installed into the test room with the pebbled side exposed by SwRI personnel. Each panel was screwed into the studs using #6 1½-in. long self-drilling bugle head screws. Each panel was installed vertically and attached using the Client-provided layout shown in Figure 1. When attaching panels to the ceiling, fastener spacing was reduced to 12 in. on center in the length direction. Care was taken to ensure that the butt joints of adjacent panels were as tight as possible. The three “non-doorway” walls and the ceiling were completely covered using the *Glasbord FPAUS*.

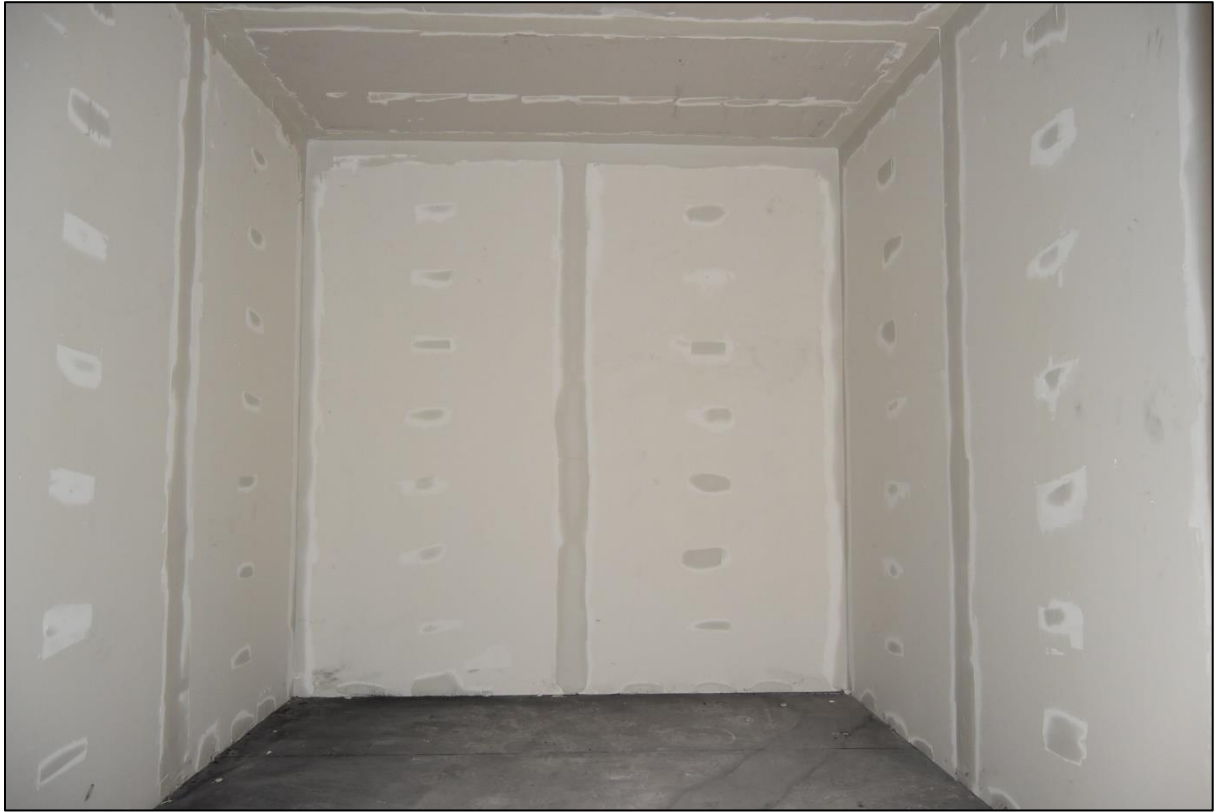
**Figure A-1. Room Construction. Gypsum prior to Sample Installation.**

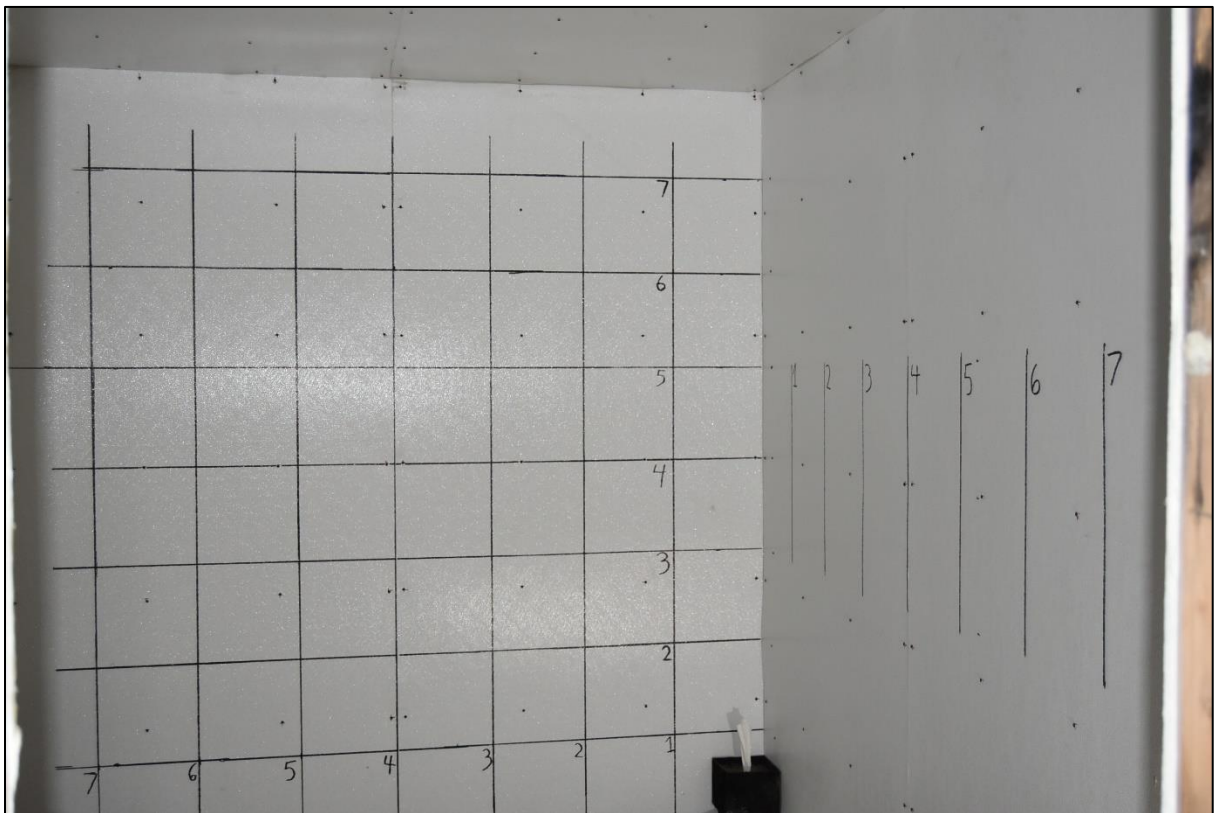
**Figure A-2. Pre-Test View of Room.**

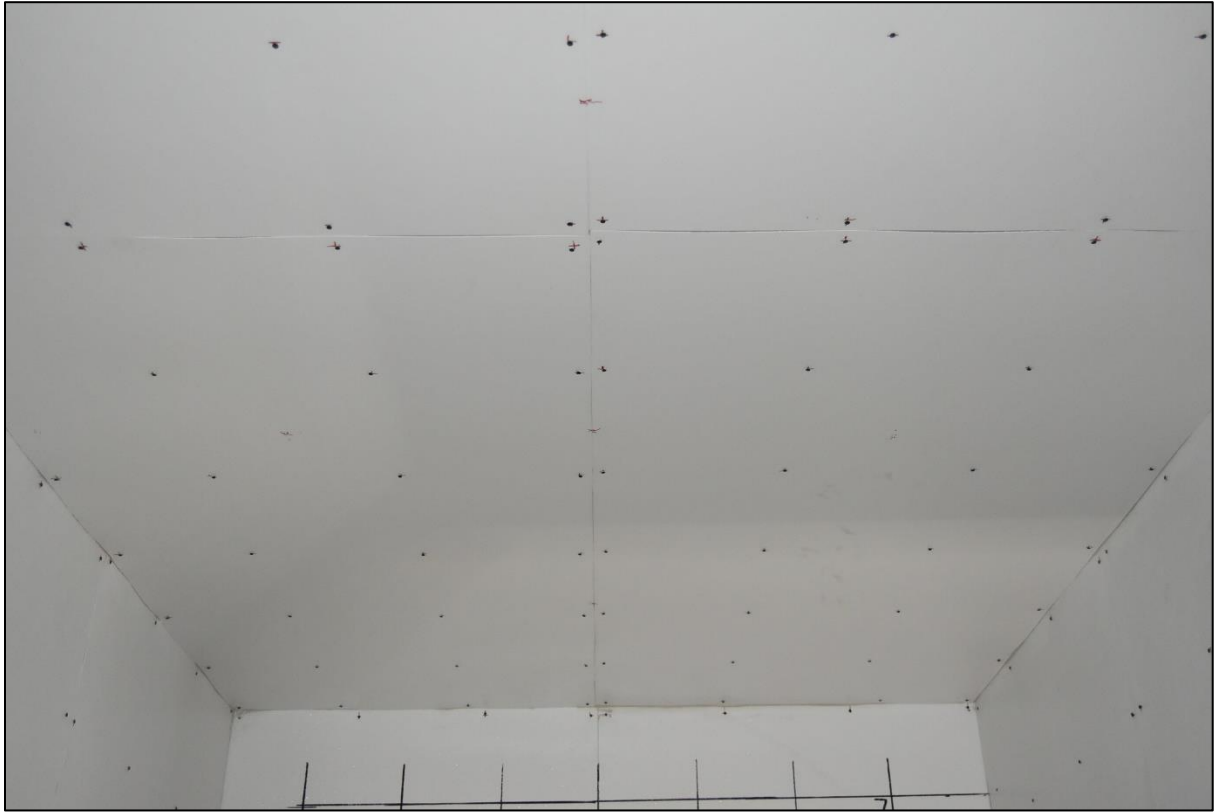
**Figure A-3. Pre-Test View of Ceiling.**

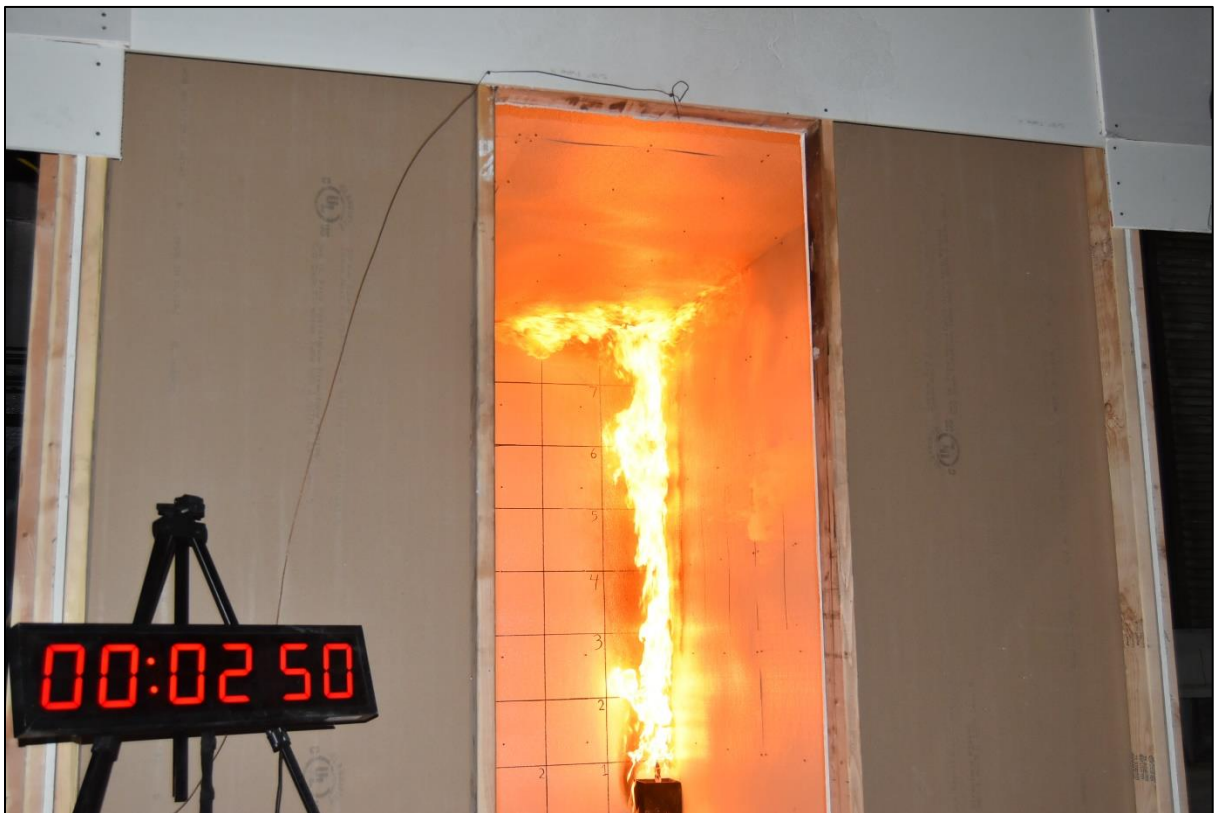
**Figure A-4. Test at 2 min 50 s, Burner Output of 100 kW.**

02:48	Ignition of the ceiling in the area of the burner impingement.
03:10	Flames from the burner reach the ceiling and spread 4–5 ft.
03:32	Darker smoke layer is forming 6 ft from the floor.

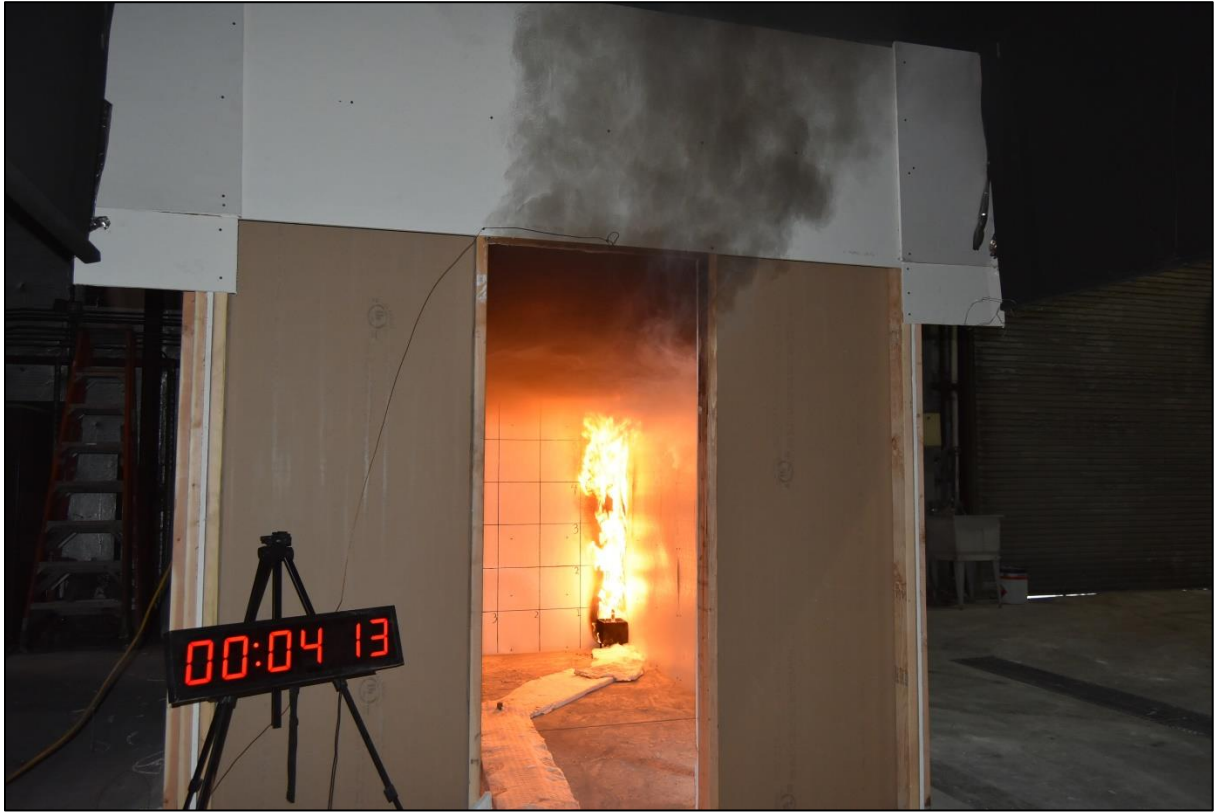
**Figure A-5. Test at 4 min 13 s, Burner Output of 100 kW.**

04:00	Smoke layer thickens and descends to 5 ft.
05:14	Ignition of the right wall.
05:35	Flames tips on the ceiling reach the left wall.
06:00	Smoke layer has somewhat dissipated.

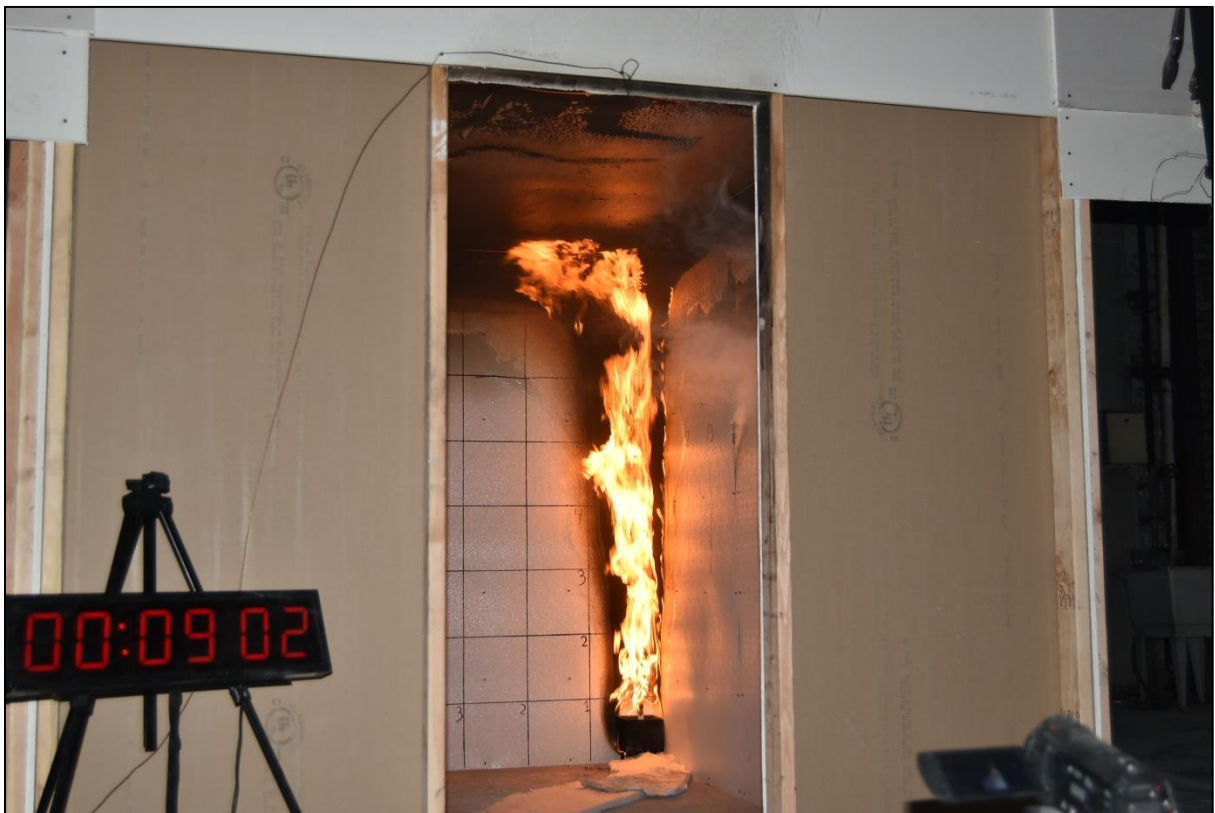
**Figure A-6. Test at 9 min 2 s, Burner Output of 100 kW.**

08:00	Burning only along the charred edges in a “V” area around the burner corner.
09:30	Very little active burner on the walls.
10:00	Burner increased to 300 kW.

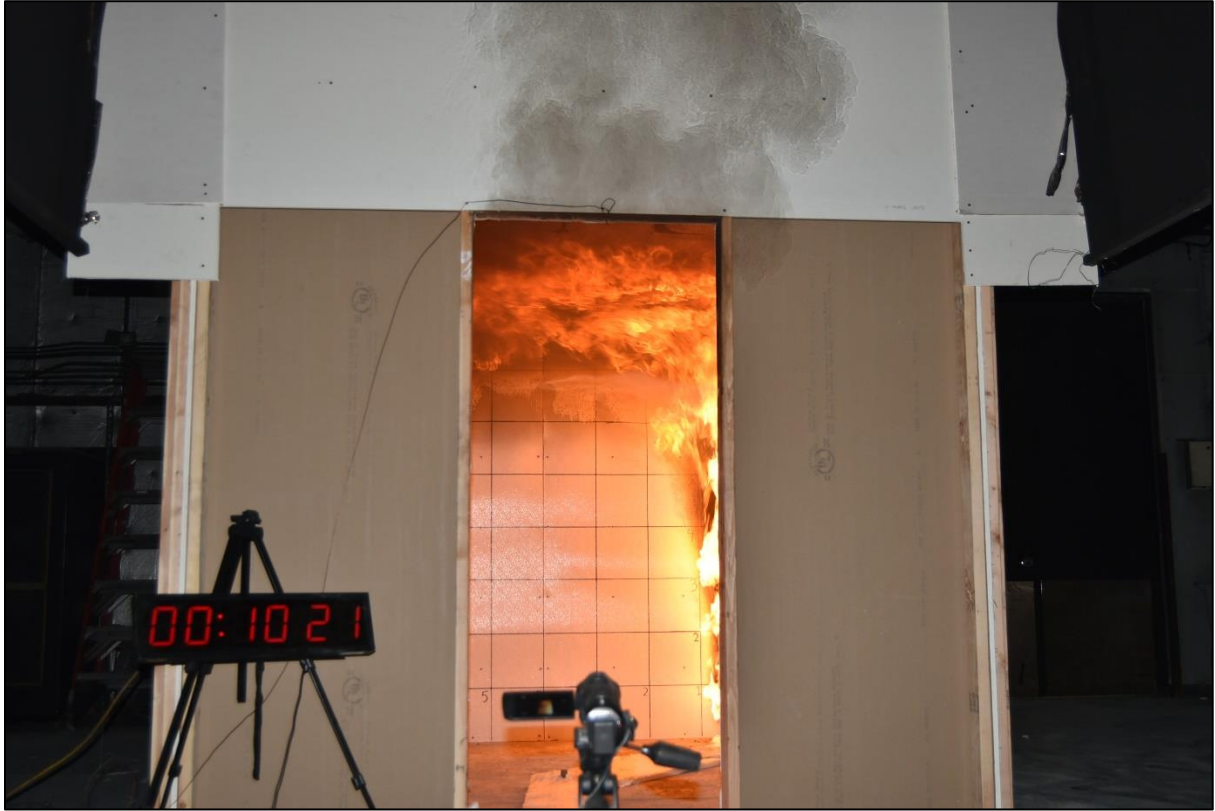
**Figure A-7. Test at 10 min 21 s, Burner Output of 300 kW.**

10:30	Flames hit the ceiling and spread 6–8 ft across the ceiling.
10:55	Smoke layer had formed at 5 ft.
11:06	Ignition of the rear and right side walls at a height of 5 ft.

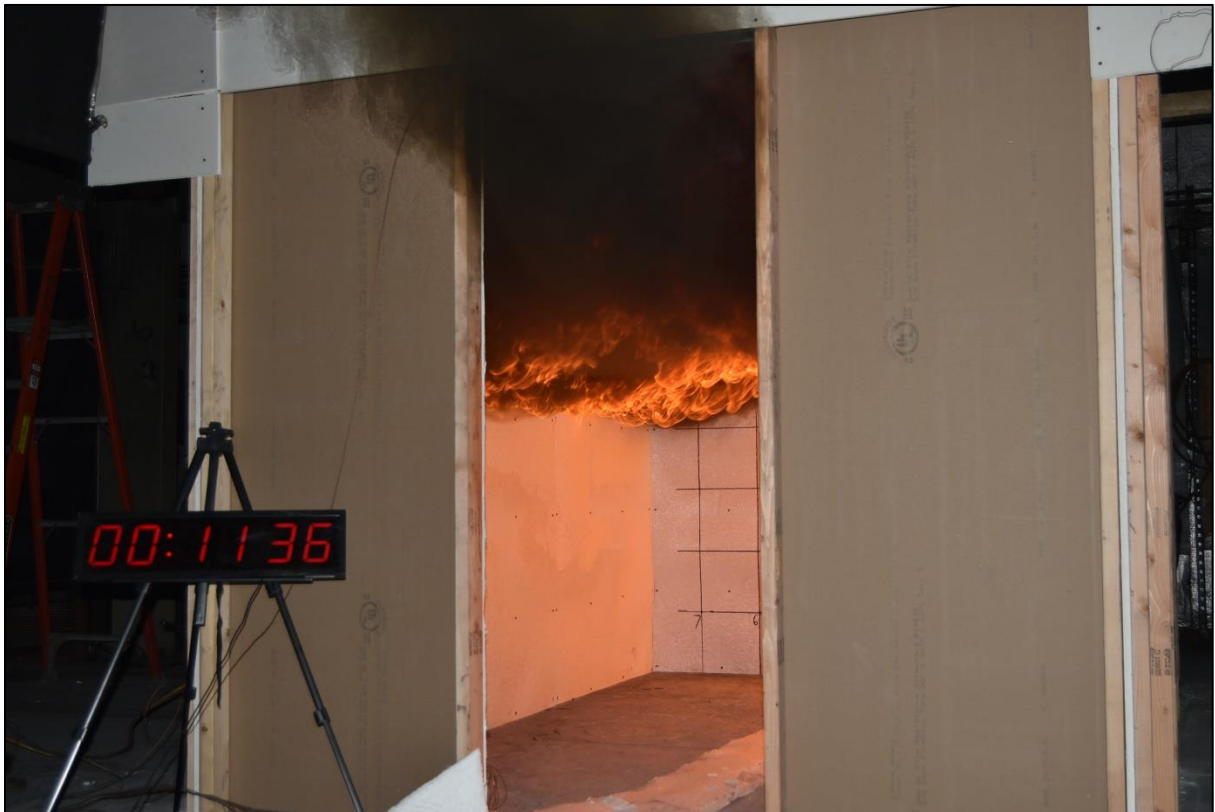
**Figure A-8. Test at 11 min 36 s, Burner Output of 300 kW.**

11:30	Smoke layer has descended to 4 ft.
11:42	Flames exiting the doorway.
12:00	Flashover conditions are present. Burner turned off.
12:23	Test Ended. Room extinguished.

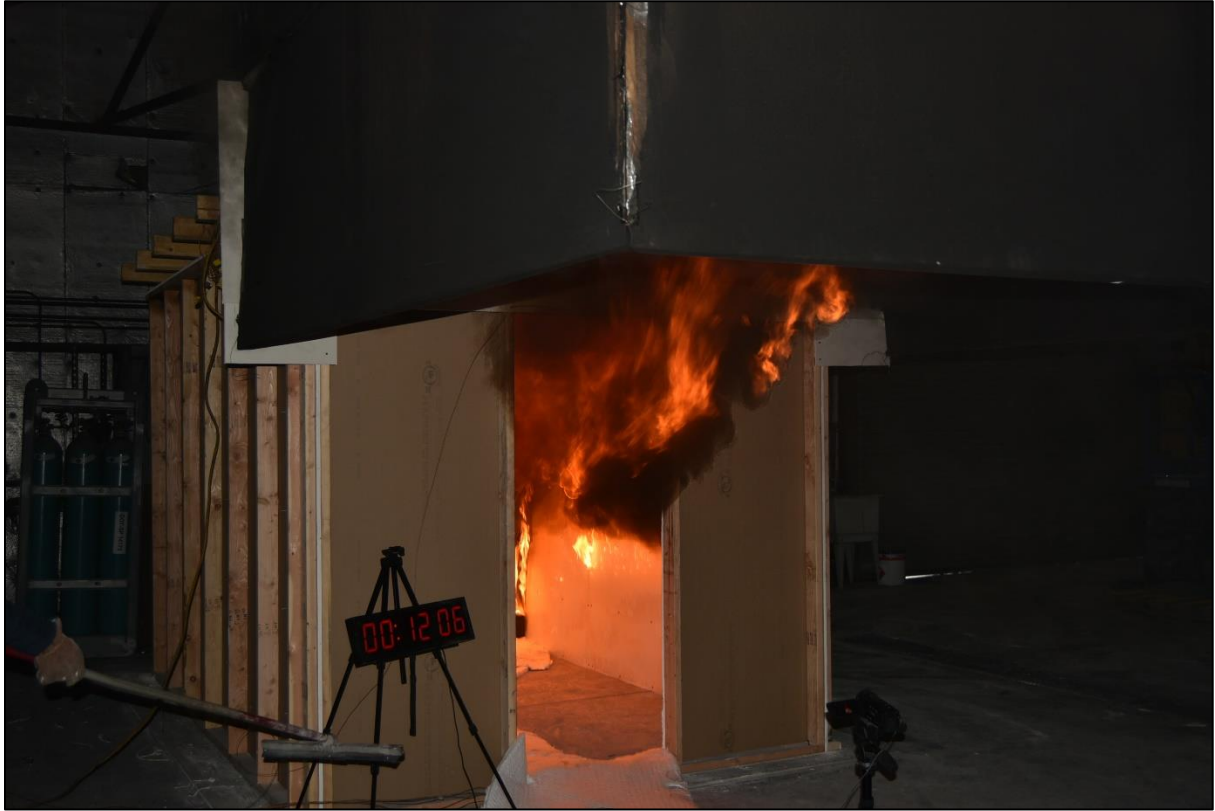
**Figure A-9. Test at 12 min 6 s, Burner Output of 300 kW. Flashover Conditions.**

Flashover is defined by AS 5637 and AS ISO 9705 as a heat release rate of 1000 kW (1 MW) or greater inclusive of the burner output. During testing of the *Glasbord FPAUS*, flashover occurred at 12 min 21 s and, therefore, is assigned a Group number of 2.

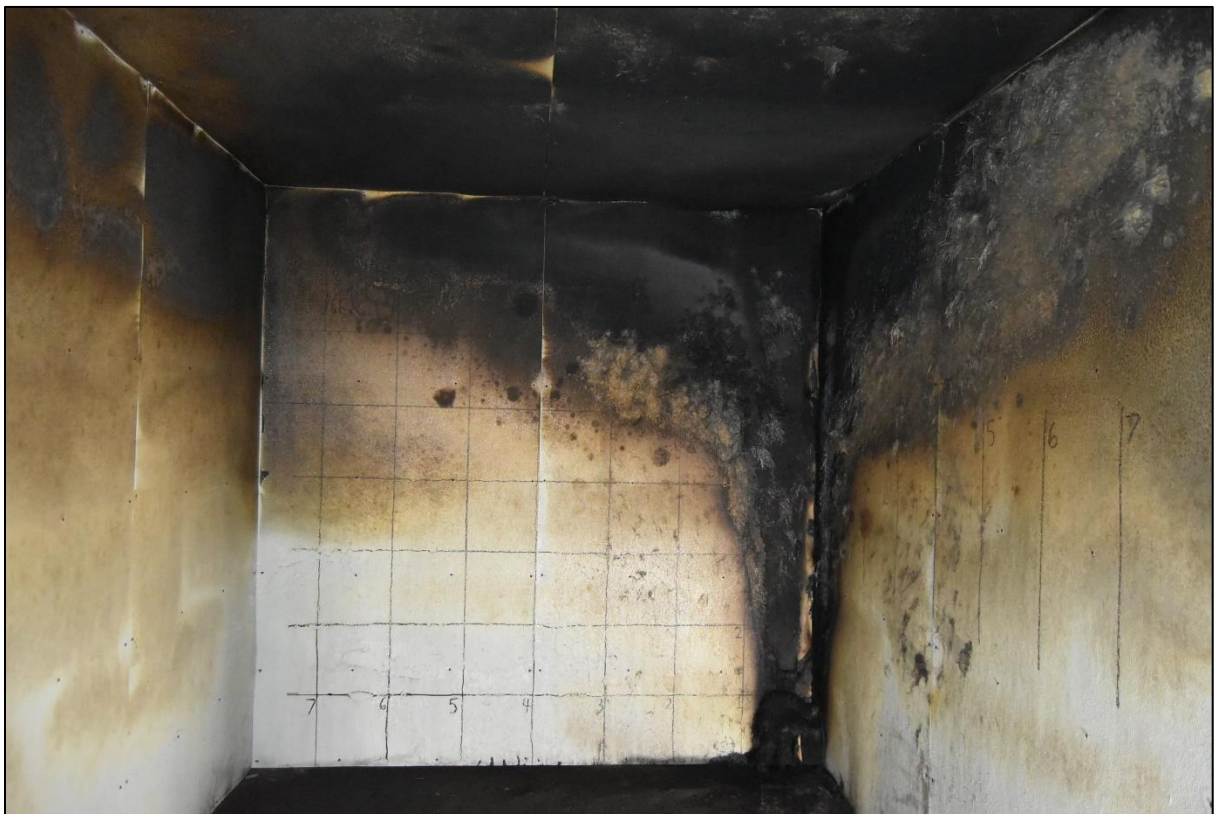
**Figure A-10. Post-Test View of Room.**

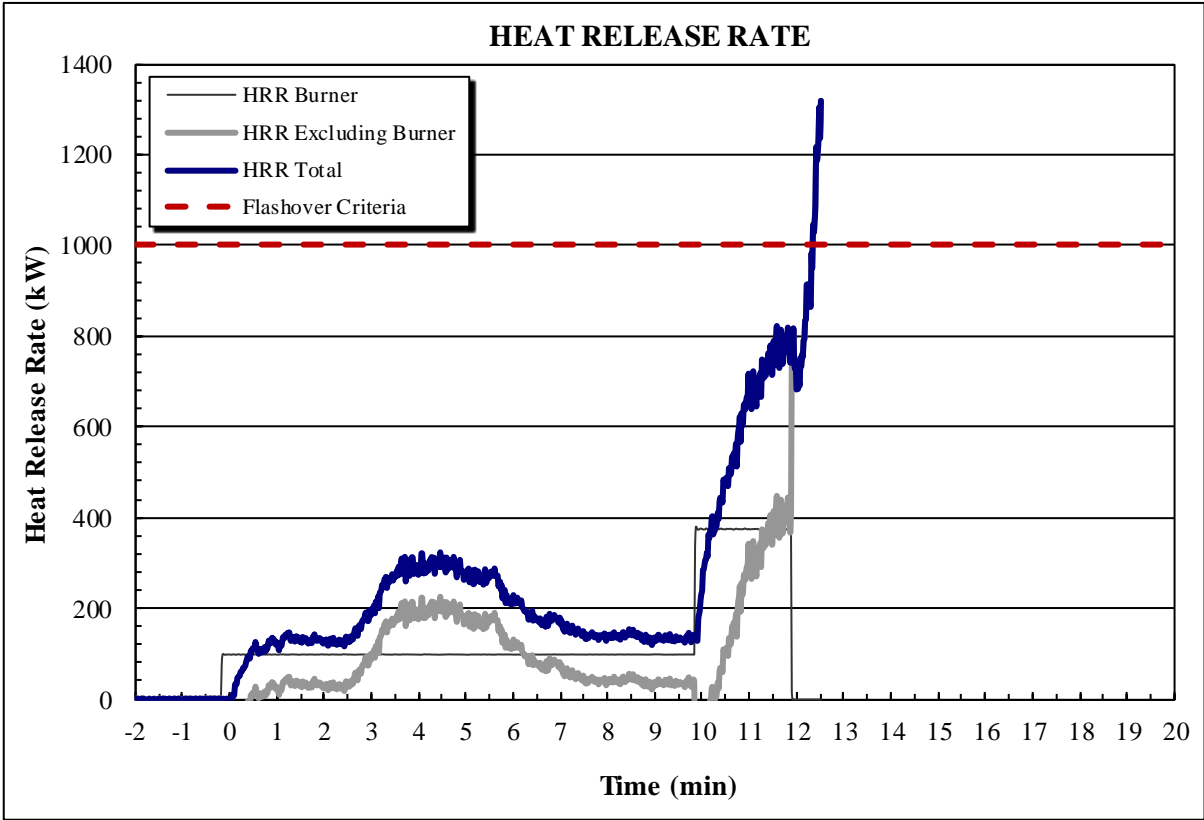
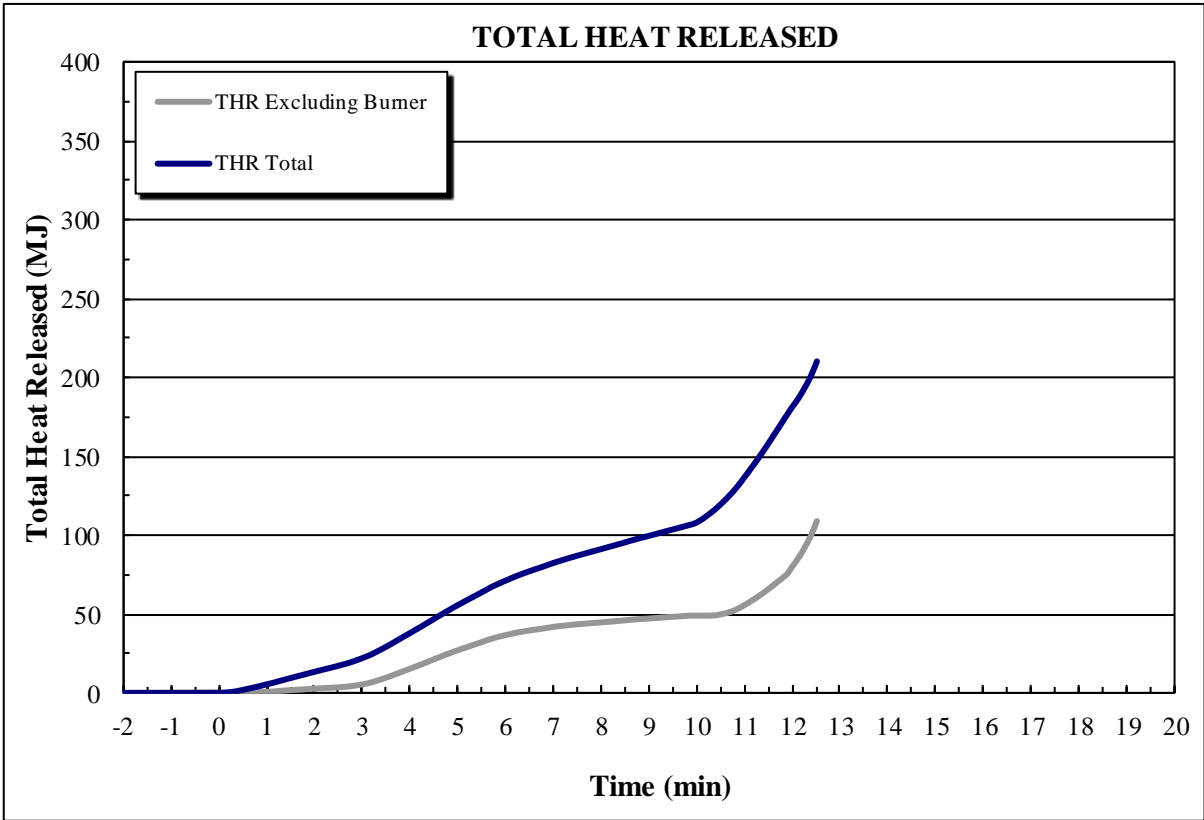
Maximum HRR <sub>total</sub>	1318 kW	at 12 min 32 s
Average HRR <sub>total</sub>	318 kW	
Total Heat Released	210 MJ	
Maximum HRR <sub>excl. burner</sub>	1318 kW	at 12 min 32 s
Maximum HRR <sub>excl. burner, 30 sec</sub>	967 kW	
Average HRR <sub>excl. burner</sub>	166 kW	
Total Heat Released (Excluding Burner)	109 MJ	
Maximum Smoke Production Rate	6.27 m <sup>2</sup> /s	at 11 min 41 s
Maximum Smoke Production Rate <sub>60 sec</sub>	4.58 m <sup>2</sup> /s	at 11 min 26 s
Average Smoke Production Rate	0.96 m <sup>2</sup> /s	
Total Smoke Released	636 m <sup>2</sup>	
Maximum Optical Density	0.99 1/m	at 11 min 43 s
Exhaust Duct Flow at Maximum O.D.	2.51 m <sup>3</sup> /s	
Average Optical Density	0.124 1/m	
Average Volumetric Duct Flow Rate	2.40 m <sup>3</sup> /s	
Maximum Heat Flux to the Floor	35.1 kW/m <sup>2</sup>	at 11 min 55 s
Max Average Ceiling Temperature	357 °C 675 °F	at 12 min 7 s
Maximum Doorway Temperature	564 °C 1048 °F	at 12 min 6 s

Maximum CO Production Rate	10.15 × 10 <sup>-3</sup> m <sup>3</sup> /s	at 12 min 30 s
Maximum CO Release Rate	11.62 g/s	
Maximum CO <sub>2</sub> Production Rate	0.075 m <sup>3</sup> /s	at 12 min 30 s
Maximum CO <sub>2</sub> Release Rate	135 g/s
